**Coal Combustion Waste Impoundment
Round 6 - Dam Assessment Report**

Vermilion Power Station (Site 015)

Fly Ash Dikes

Dynegy Midwest Generation, Inc.
Oakwood, Illinois

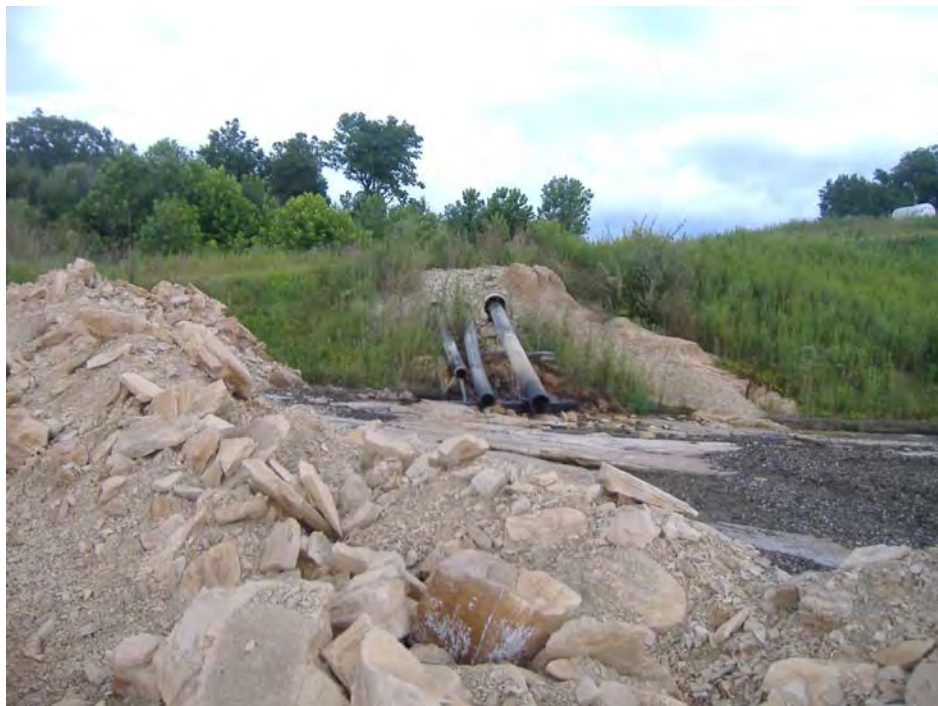
Inlet Pipes

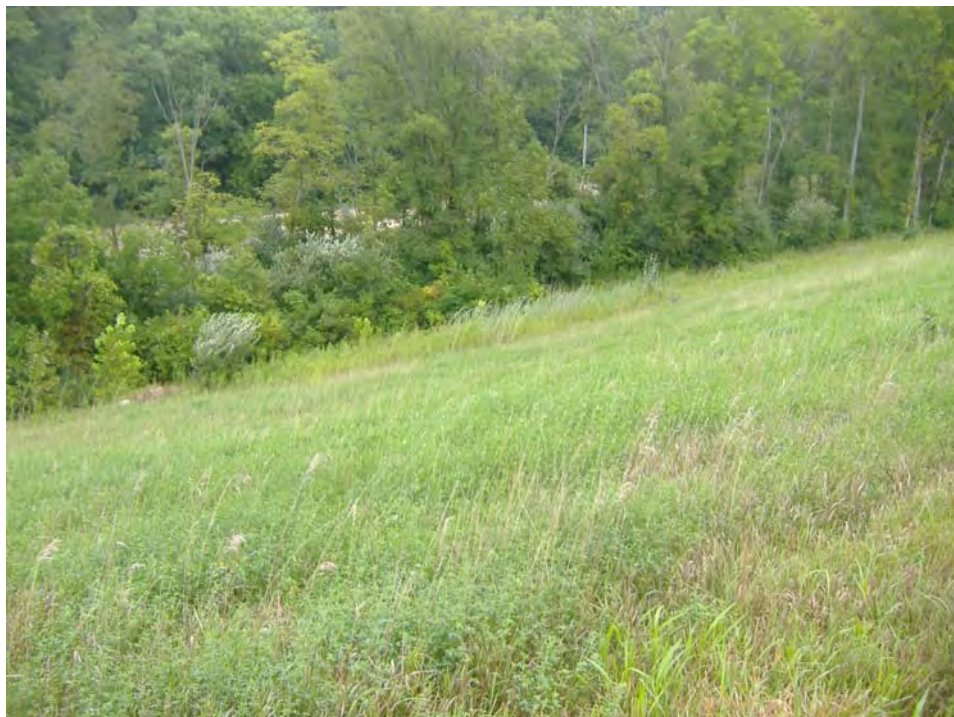
Primary Pond Typical Downstream Slope

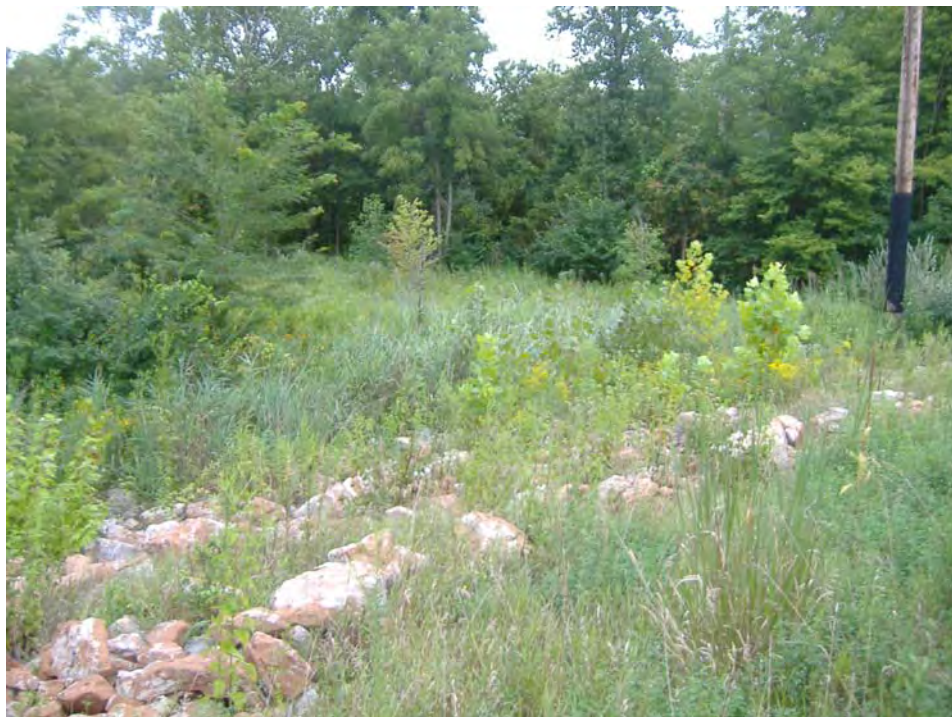
Primary Pond Rip Rap on Downstream Toe

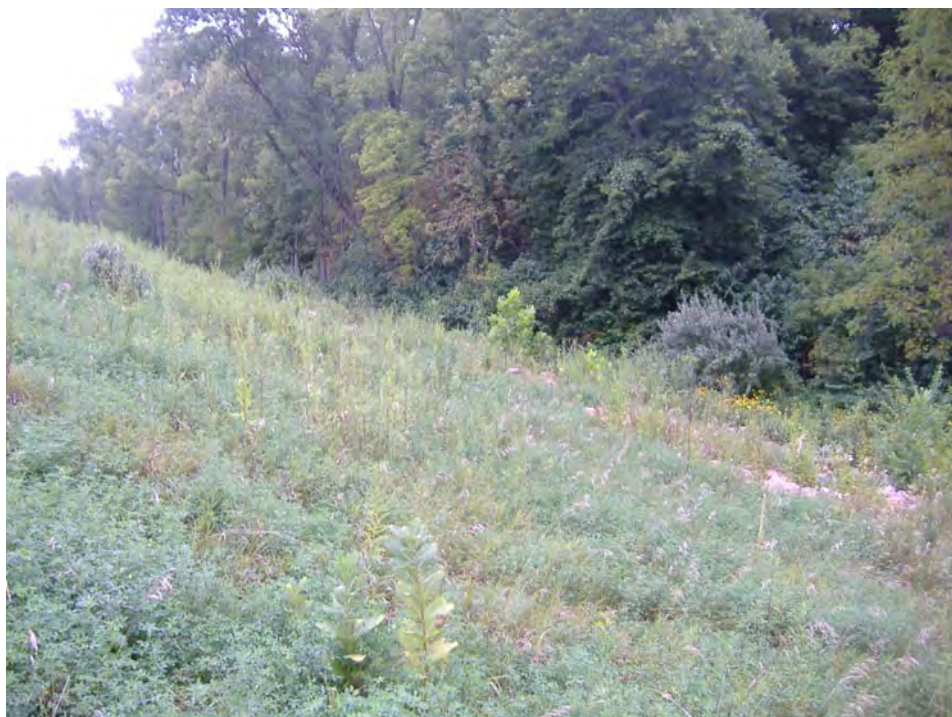
Primary Pond Typical Downstream Slope

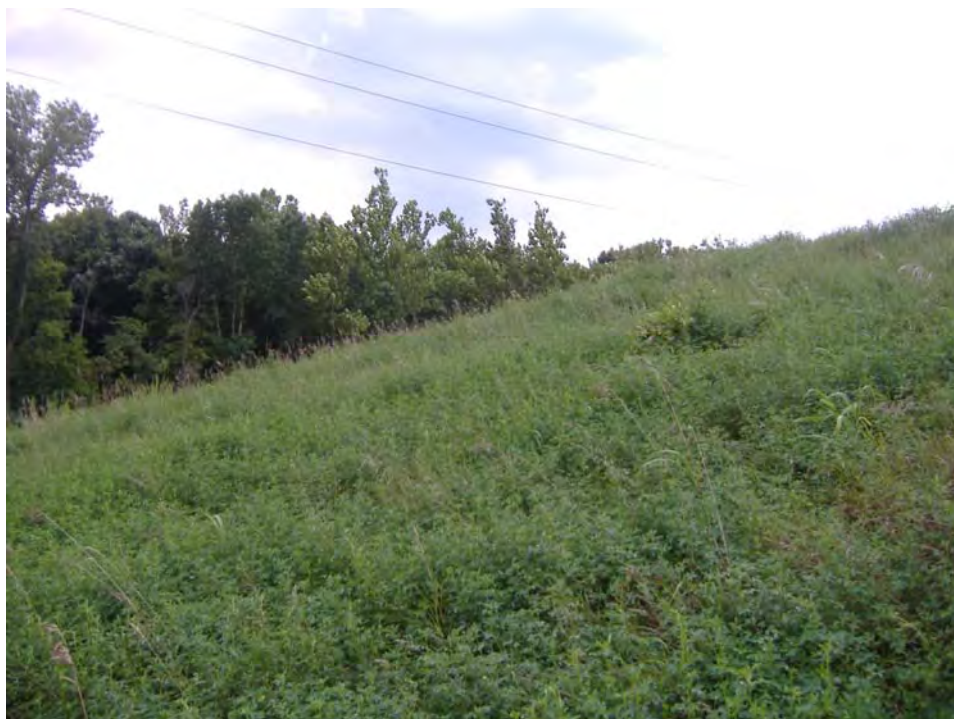
Primary Pond Typical Downstream Slope

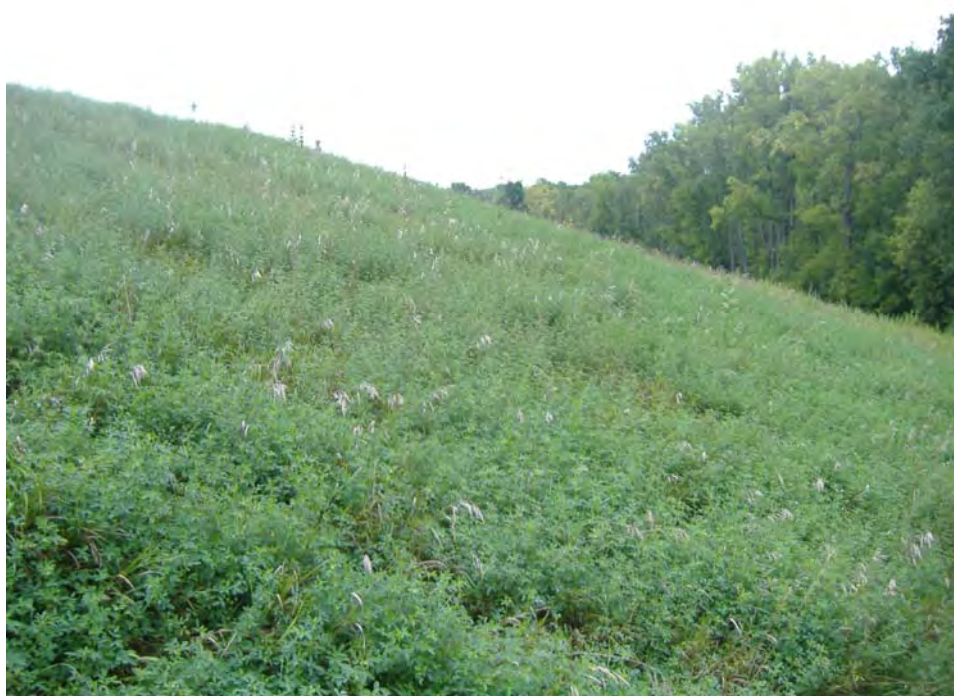
Primary Pond Typical Downstream Slope

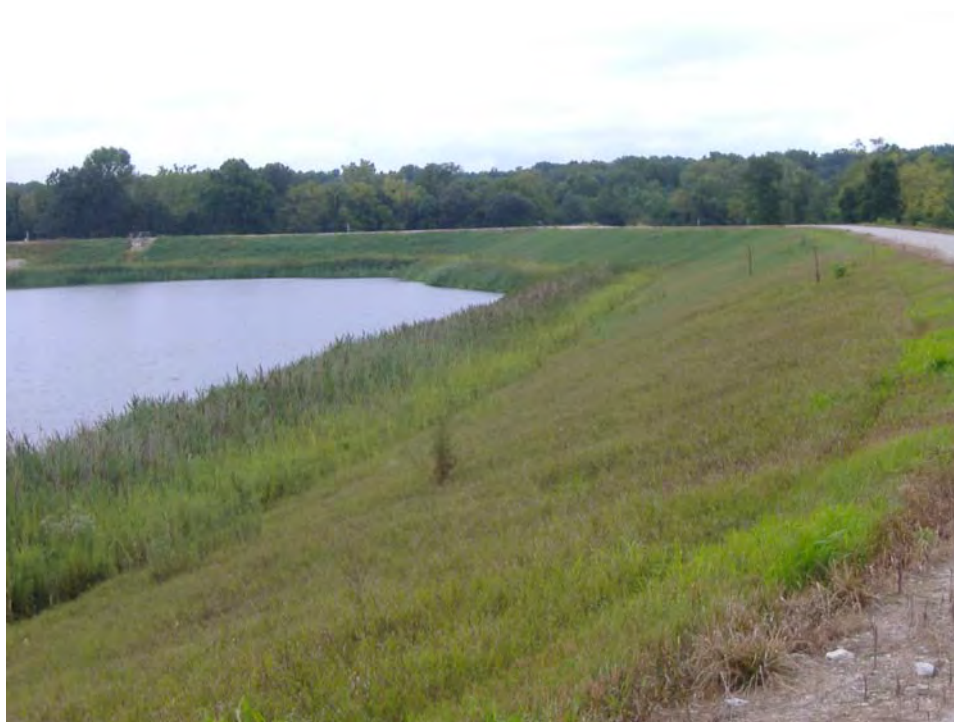
Primary Pond Typical Upstream Slope

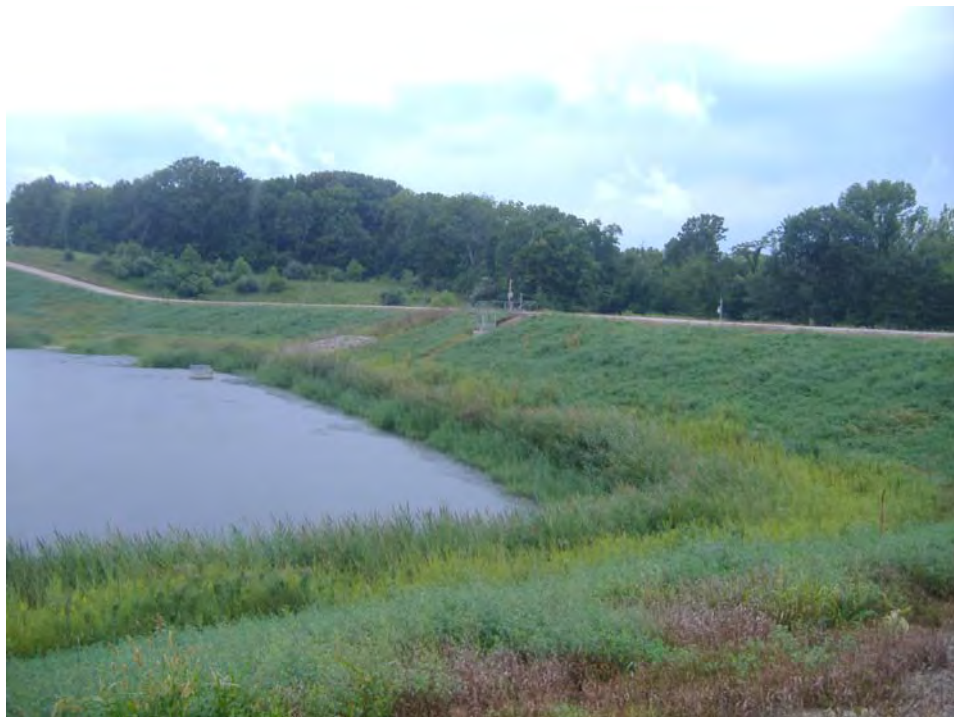
Primary Pond Typical Upstream Slope

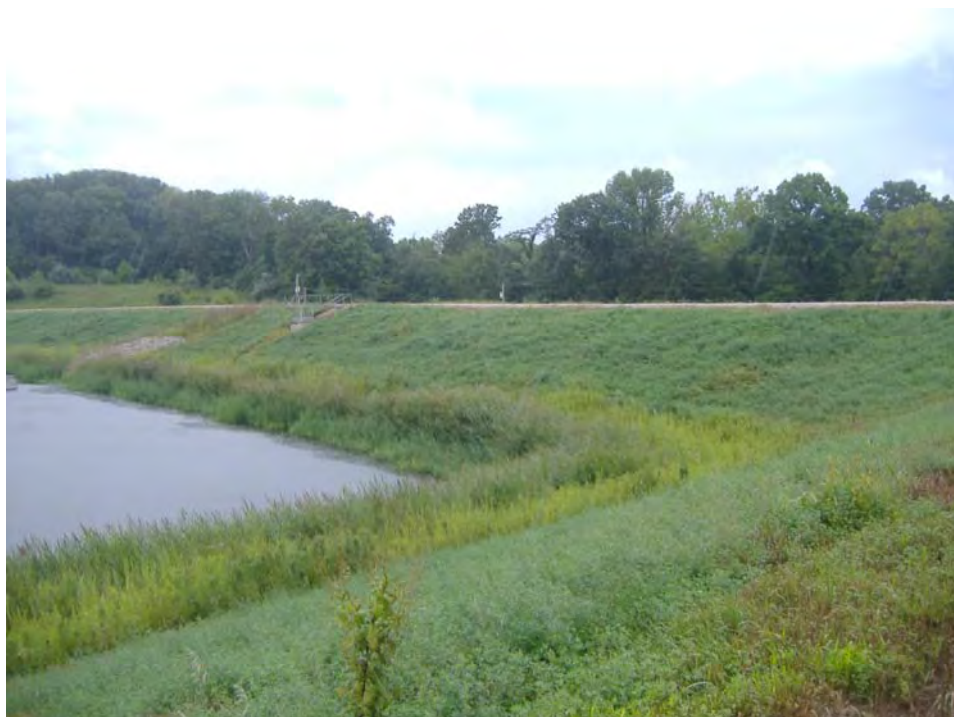
Primary Pond Typical Upstream Slope

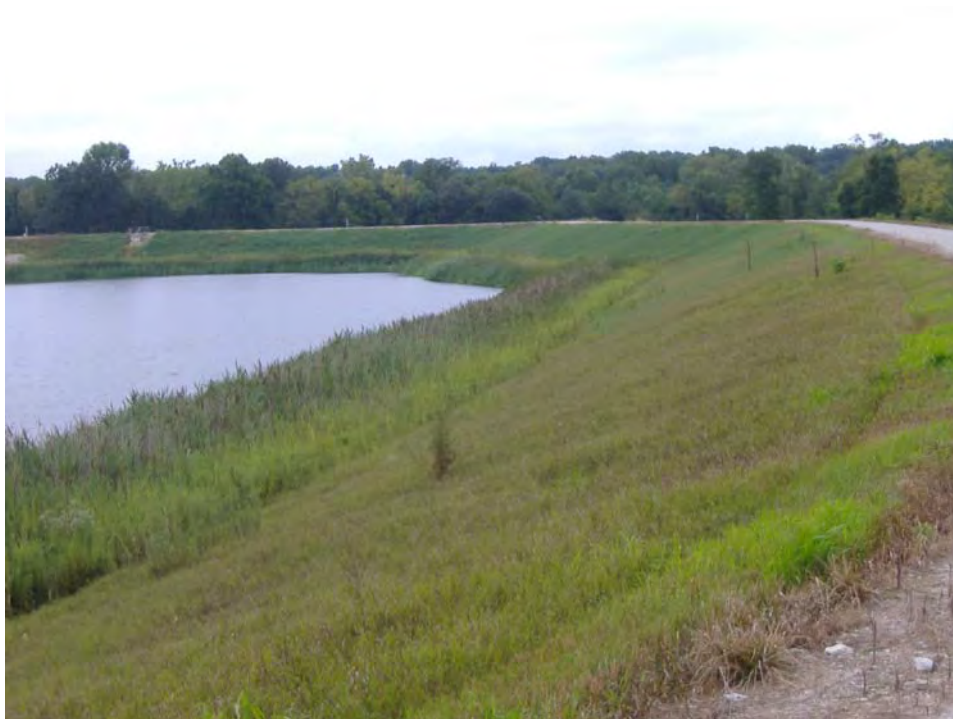
Primary Pond Typical Upstream Slope

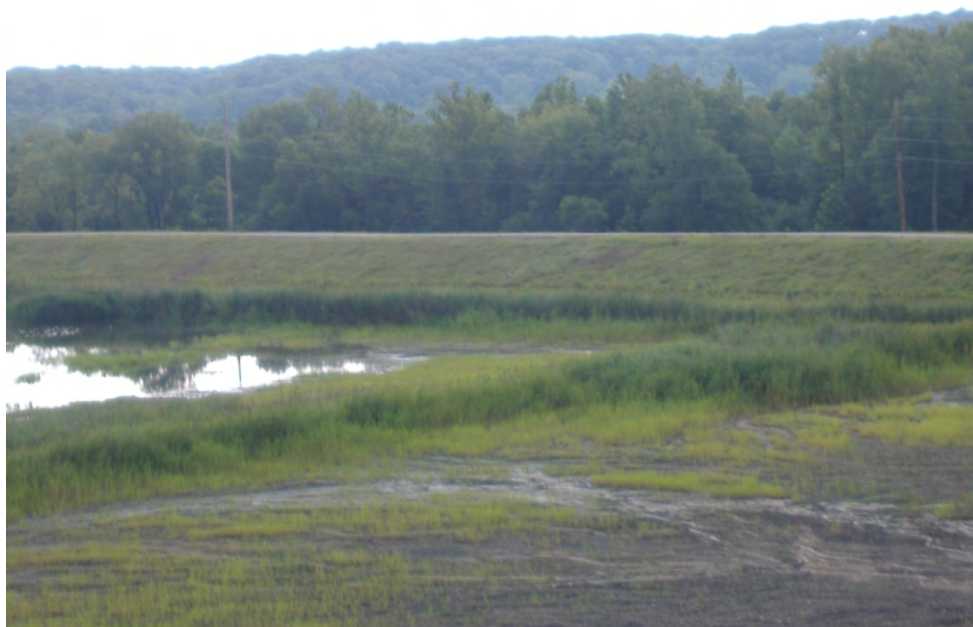
Primary Pond Typical Upstream Slope

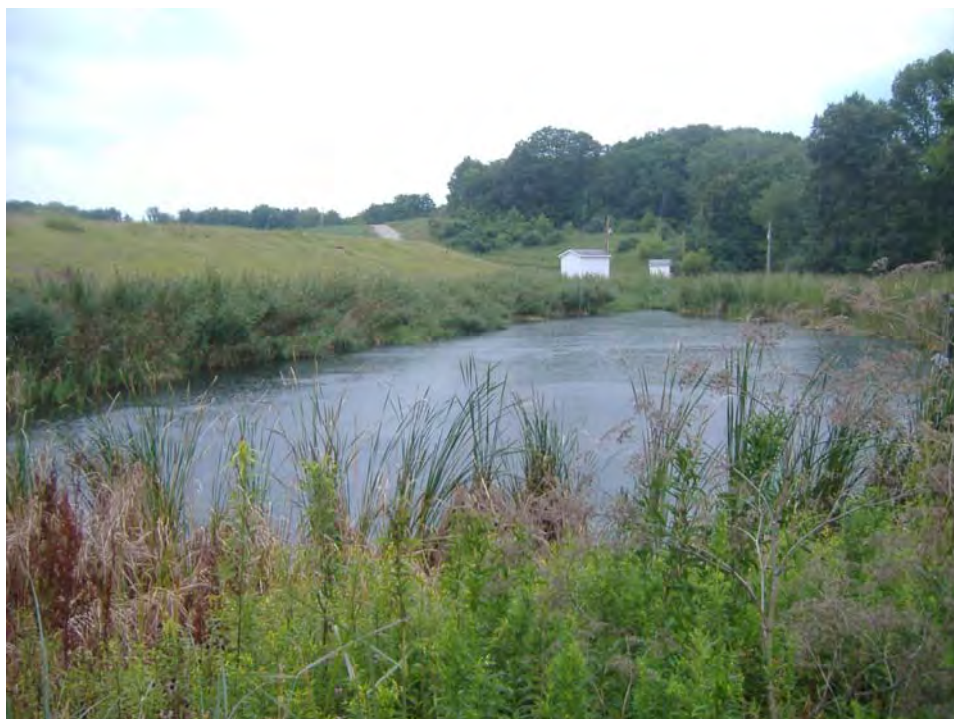
Primary Pond Settlement Marker
